COATED
STEEL SHEET

COATED STEEL SHEET

ALCOSTA (Hot-dip aluminized steel sheet)

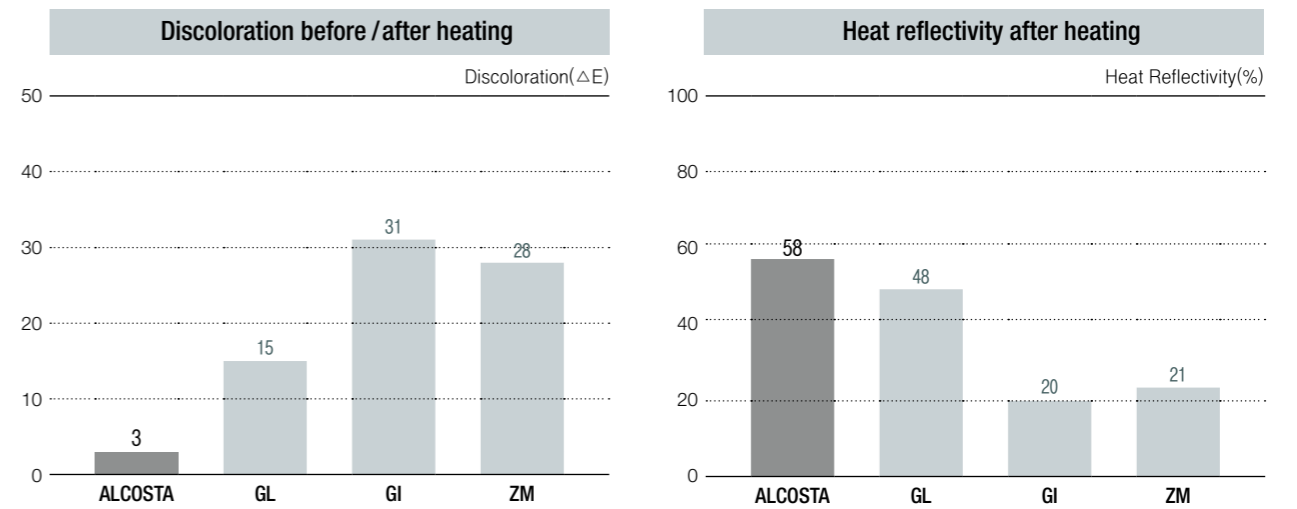
| Comparison by coating material (at 400°C, 24Hrs) |

The surface of ALCOSTA is very beautiful and has outstanding heat reflectivity. It is used for thermal reflectors in toaster, gas range, oil stove, gas oven, clothes dryer, etc.

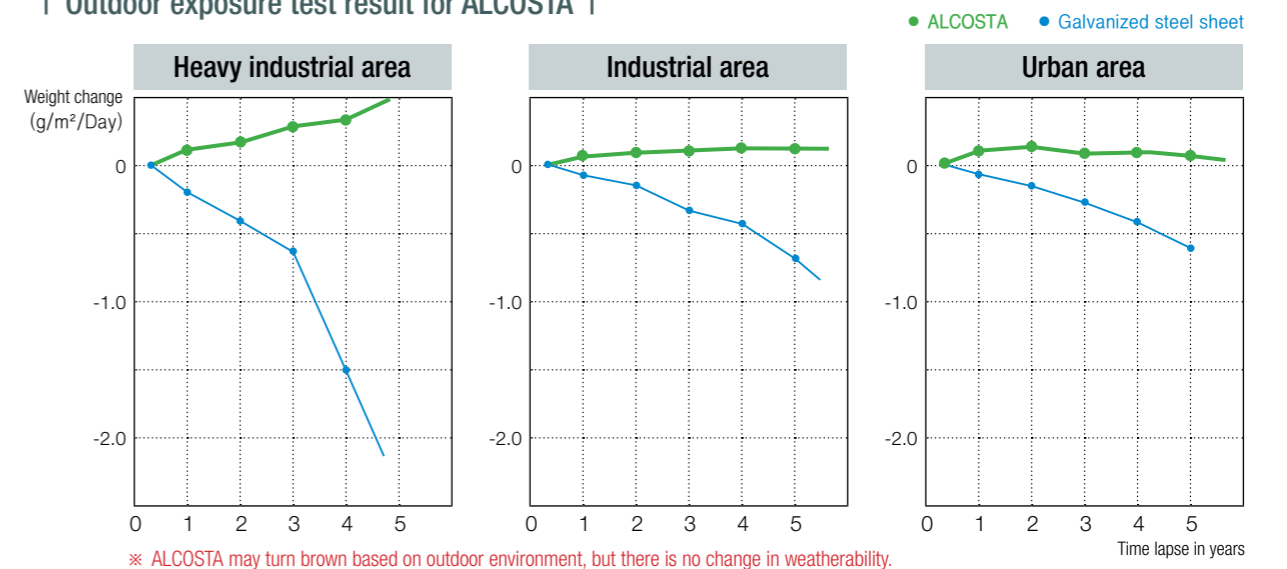
Outdoor exposure test result for ALCOSTA

ALCOSTA forms a fine, stable oxide layer on the surface, and offers outstanding weatherability in severely corrosive environments of industrial areas.

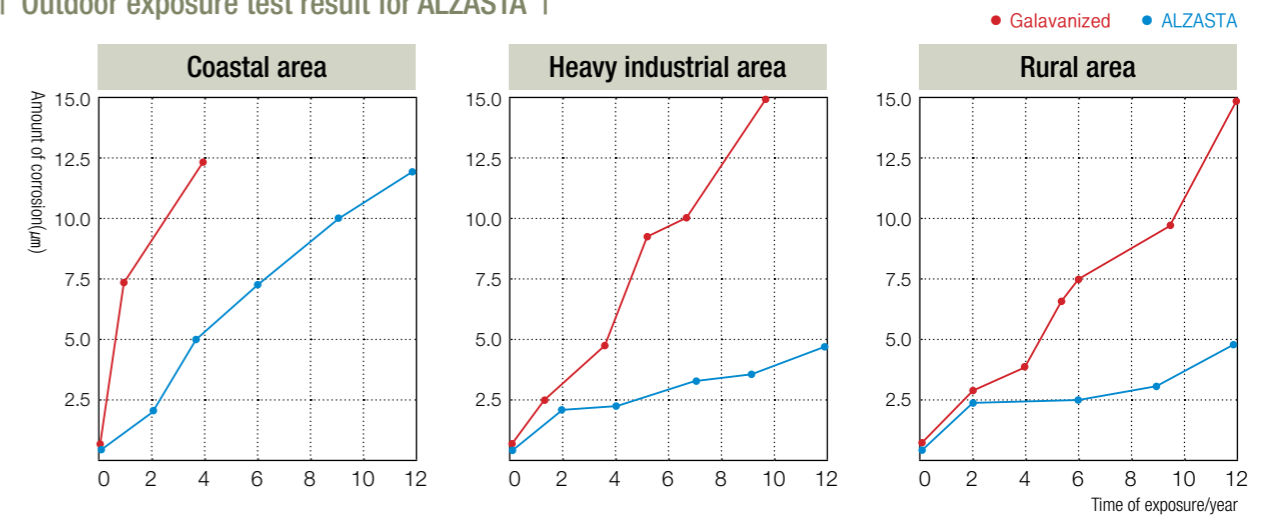
| Outdoor exposure test result for ALZASTA |

ALZASTA offers over 4 times more corrosion resistance than galvanized steel sheets in various corrosive environments. This is due to the sacrificial effect of galvanized steel sheet caused by stable corrosion product under corrosive environment and dense oxide coating creation by aluminized steel sheet.

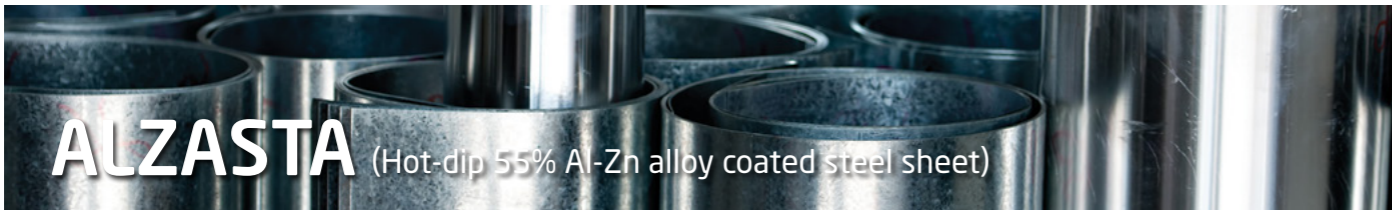
| Corrosion resistance by product (flat surface) |

Galvanized steel sheet	100hr	500hr	1580hr	1860hr
AZ (70g/m ² , Both Side)				
GI (140g/m ² , Both Side)				—

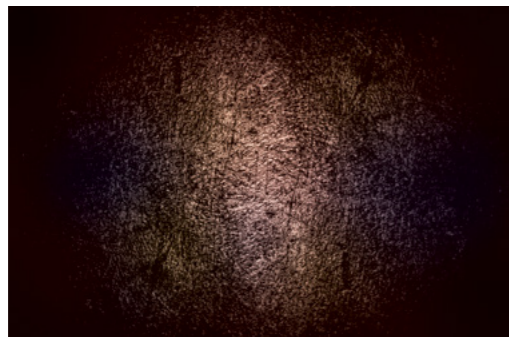
Ball Impact Test

No peeling off in 1kg, 500mm impact test

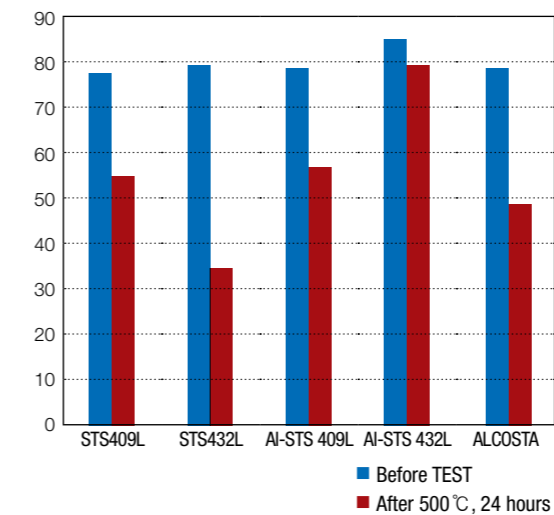
- Test Conditions: 500 °C, 24 hours
- Test Materials : STS 409L(11%Cr), STS 432L(17%Cr-0.5%Mo), AI-SUS 409L, AI-SUS 439, ALCOSTA

A smaller difference in whiteness (before and after the test) indicates a better product. ("Whiteness" refers to the brightness/darkness level of the surface.)

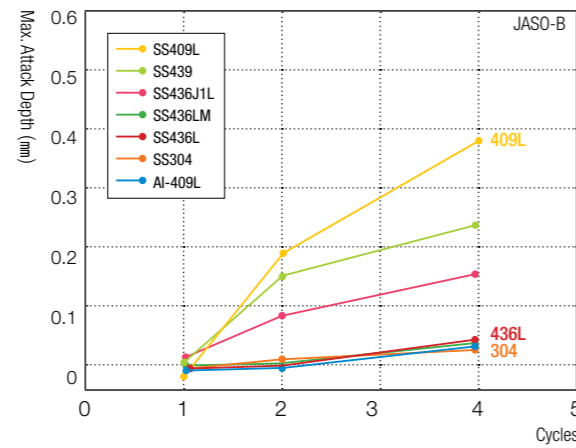
Category	Test condition
Solution (ppm)	Cl-100, NO ₃ -20, SO ₃ ²⁻ -600, SO ₄ ²⁻ -600, CH ₃ COO- 800
pH	8.0
Temperature	80°C
Time	24 days
Pattern repetition	Repeat 300cc, 24Hr evaporation 5 times, and heat once at 250°C for 24Hrs

※ AI-STS409L has better interior corrosion resistance than 409L and 439, but lower than 436L and 304.

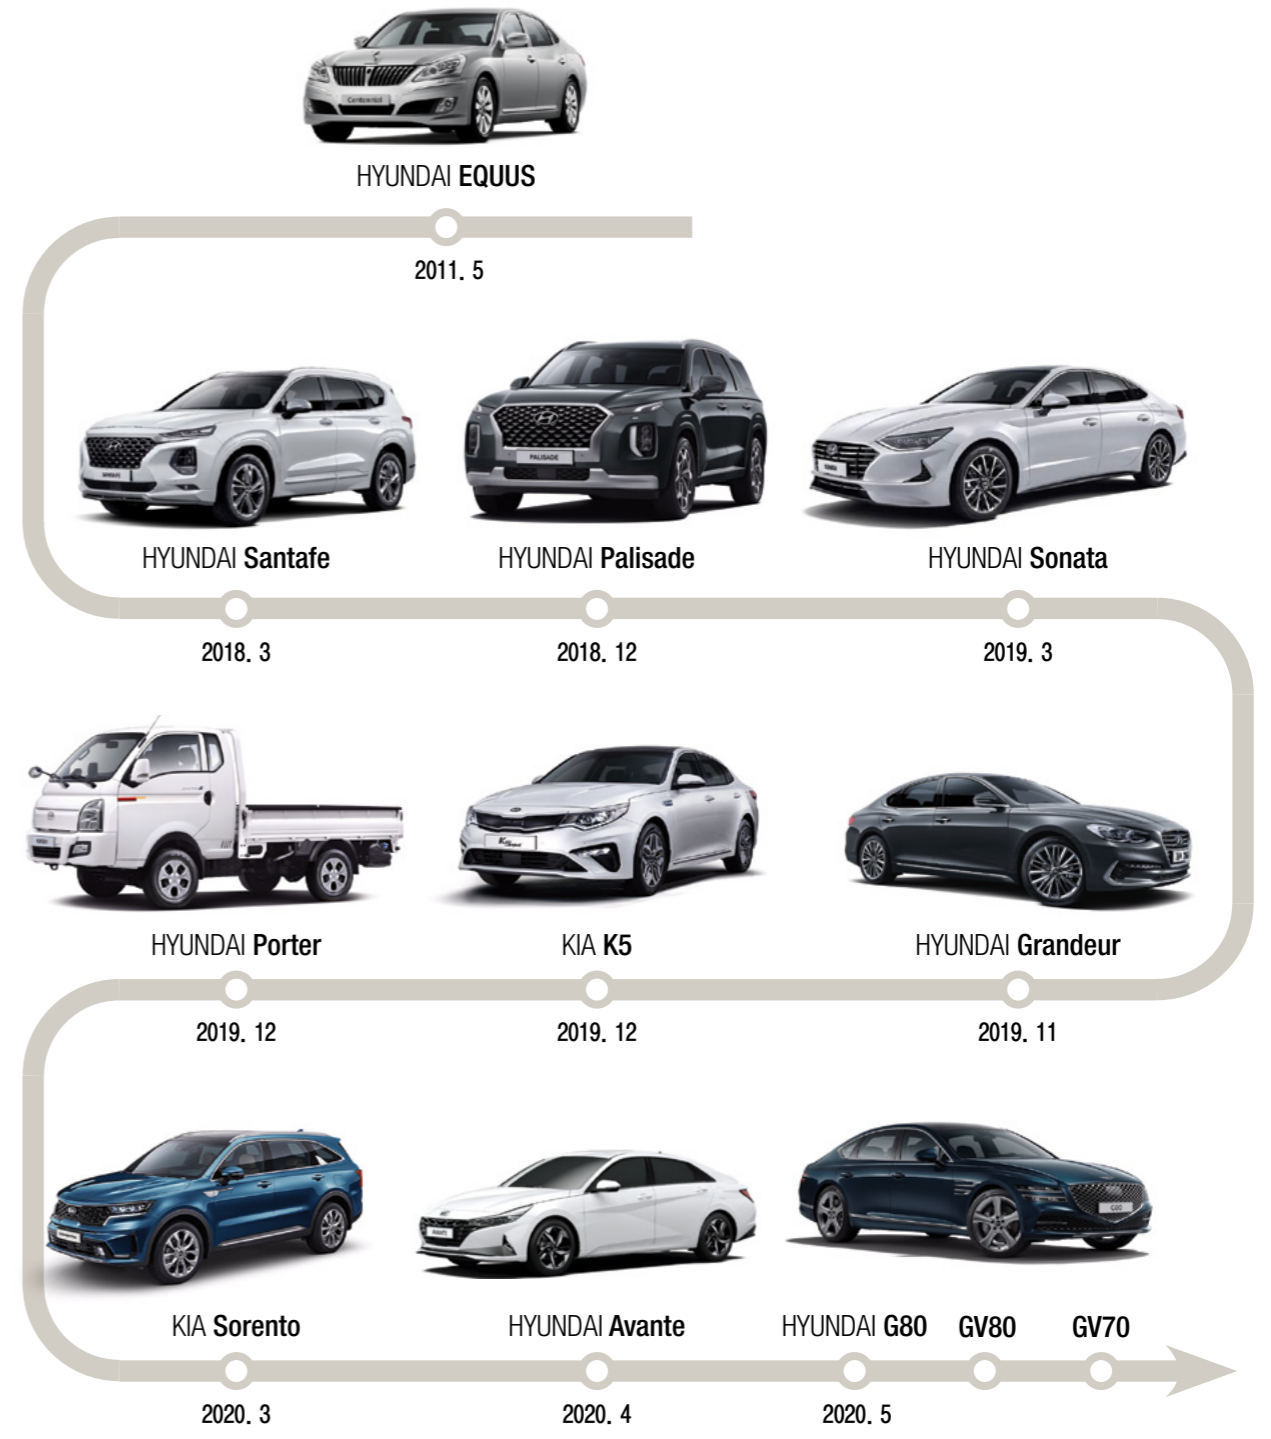
| Application in Hyundai-Kia Motors |

※ Applied in all models including G90, Tucson, Kona, K3, etc. in addition to above models

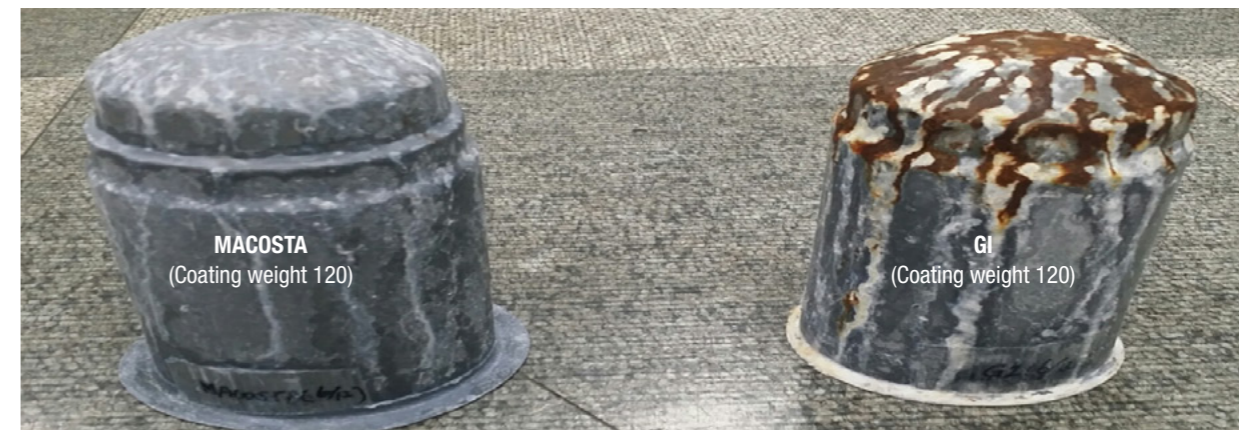
| Automobile fuel filter housing |

※ No red rust on MACOSTA after 600 hours based on SST → Outstanding formability

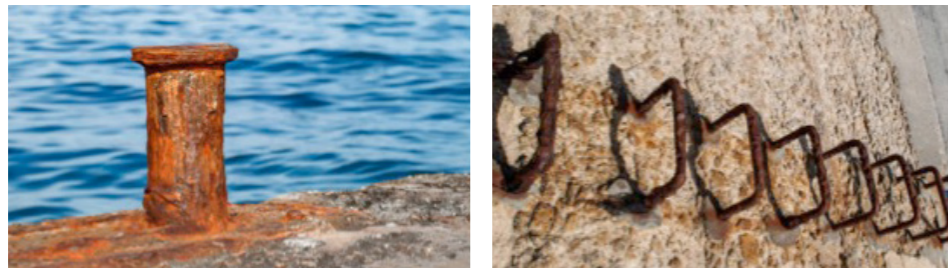
Avoiding Contact with Concrete

Avoid direct contact with concrete. When concrete becomes wet, its alkaline components can leach out and dissolve the plating on the steel surface. In addition to insulating the steel from concrete, make sure to design a structure that prevents rainwater and condensation from infiltrating.

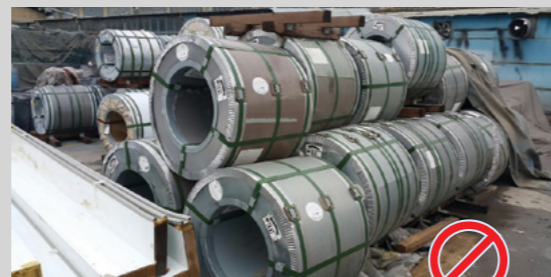
▲ Incorrect outdoor storage (cover not used)
